Blistering in SBS Polymer Modified Bituminous Roofs

by *K.K.Y. Liu, R.M. Paroli and T.L. Smith*

This Update, based on an IRC study, describes causes of blistering in styrene-butadiene-styrene (SBS) modified bituminous roofs, suggests ways to prevent it and recommends methods to deal with it.

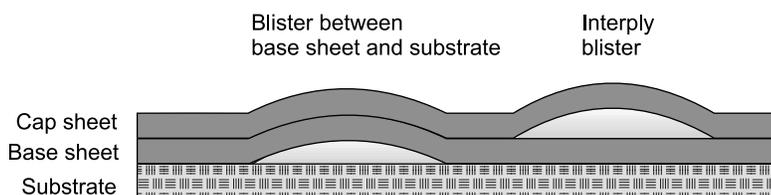
Figure 1. Blistering locations in modified bituminous membranes

In asphalt-based roofs, blisters occur frequently. Blisters are pockets of entrapped air and/or moisture in roof membranes. They can occur between the cap and the base sheets and/or between the base sheet and the substrate (Figure 1). Blisters range from barely detectable spongy spots to bloated humps several square metres in

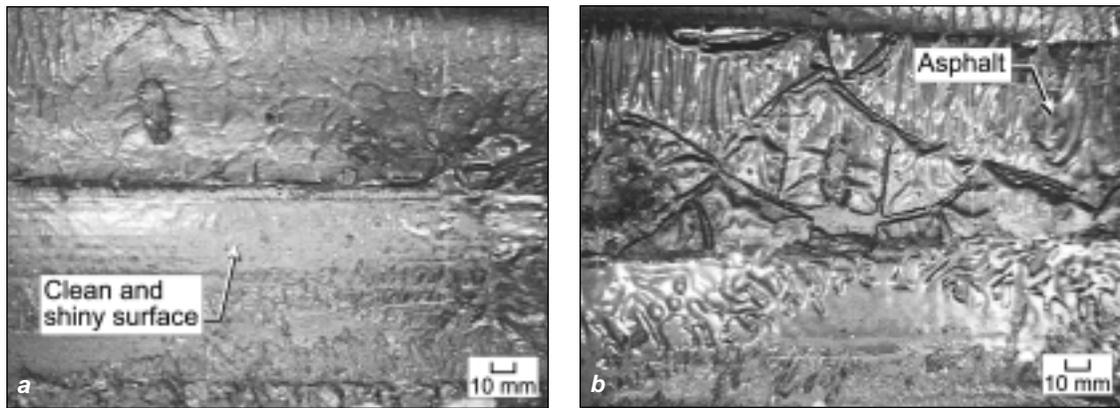
Figure 2. Poor interply bonding due to low application temperature
(a) Cap sheet, (b) Base sheet

Good interply bonding is important to resist blister growth. During hot application, the asphalt should flow readily to “wet” the surface of the sheet and remain hot enough until the cap sheet is put on. Otherwise, the bonding between the sheets will be poor, and blister growth will be encouraged. Figure 2a shows the underside of the cap sheet of a blister. It is shiny and clean, with almost no asphalt adhered to it. Since the interfacial bonding between the asphalt

and the base sheet appeared to be good (Figure 2b), the temperature of the mopping asphalt was initially high enough. It is suspected that the asphalt cooled rapidly during the mopping process, so that the temperature fell below the equiviscous temperature (EVT) range of the asphalt before the cap sheet was put on. To minimize temperature drop, the cap sheet should be applied as soon as the asphalt is mopped.

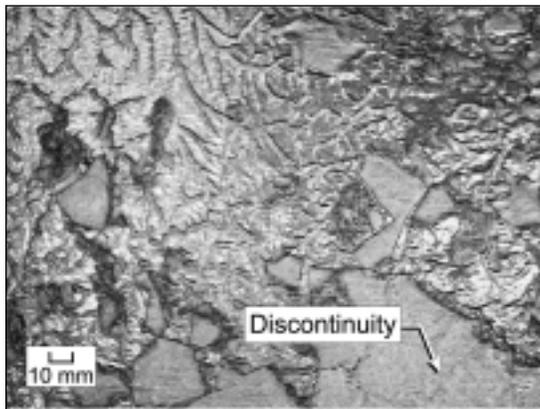
Figure 3. Discontinuity in mopping asphalt due to non-uniform mopping process

The mopping asphalt should be applied uniformly. In Figure 3, the discontinuities seen in the asphalt were likely the result of mopping skips caused by the lack of uniformity in the mopping process. The mopping asphalt in this sample was found to contain foreign bodies (sand, fillers, aggregates or other contaminants). These foreign bodies may make the asphalt more difficult to handle and mop uniformly. As a result, skips occur in the mopping, and become voids. It is important to remember that mopping asphalt is primarily an adhesive between the modified bituminous sheets, and adhesives work best applied in thin layers.

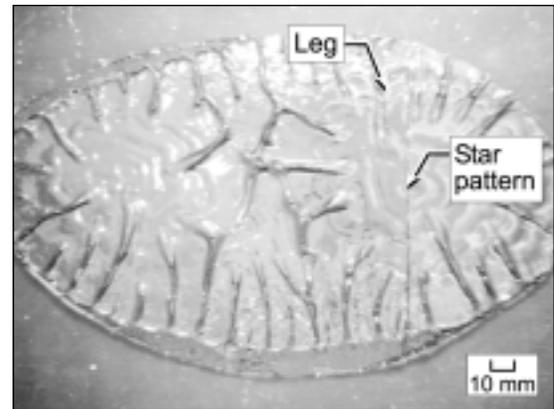
Figure 4. Uncoated spots are potential origins of blisters.

Uncoated spots are also potential origins of blisters. The “star-like” uncoated patterns in Figure 4 were likely the origins of the two adjoining blisters. The centre of the pattern was bare, with almost no asphalt adhering to it. The “legs” (or stalactites and stalagmites) bridged the cap and the base sheets inside the periphery of the blister. These “legs” were likely formed by the yielding and stretching of the mopping asphalt at the periphery of the void, during the expansion of the blister at high temperature. One possible cause was the presence of liquid parting agent at the interface of the cap and base sheets. Liquid parting agent was sometimes applied in the past to the ply and base sheets to prevent sticking in the roll, but is rarely used now. Another possible cause was that the membrane was not flat when it was rolled out during mopping. The cap sheet bonded well to the base sheet at the flat areas but voids were left between the sheets at the raised, uneven areas. These voids may not be noticeable during installation but they grow with time.
